The Command System Malfunction of the *Telstar* Satellite

By J. S. MAYO, H. MANN, F. J. WITT, D. S. PECK,
H. K. GUMMEL and W. L. BROWN

Loss of the command function of the Telstar satellite first occurred on November 24, 1962. There had been earlier indications of degraded performance. Facts are presented which led to the conclusion that the malfunction of the command system was due to surface damage to certain transistors in the redundant command decoders by the enhanced radiation in the inner Van Allen belt.

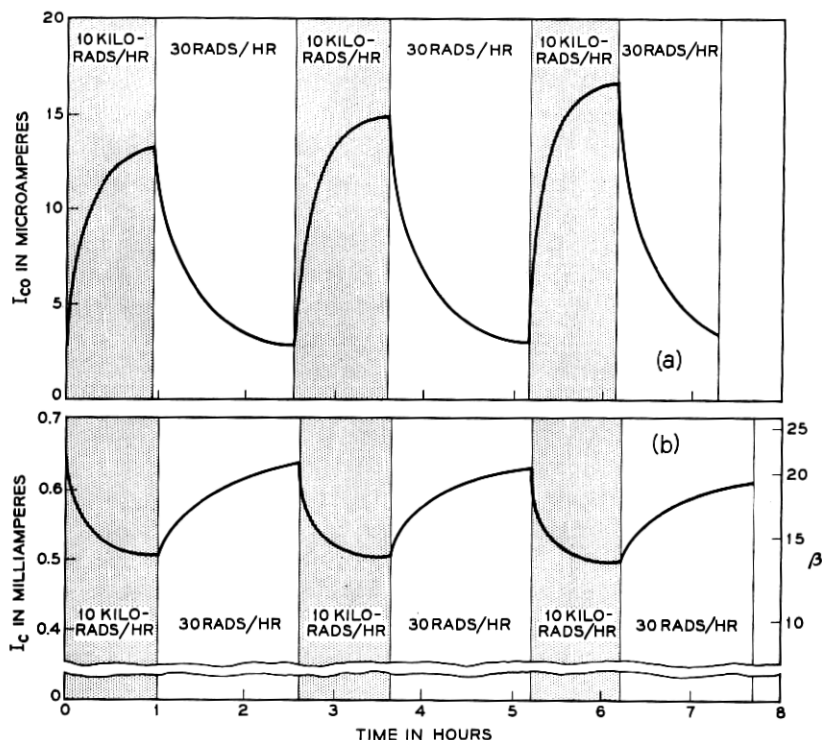
Fig. 4 — Leakage current and gain of a transistor cycled between high and low radiation field intensities.

(i) Those units which were heavily degraded in the high-intensity field partially recovered in the low-intensity field. The time constant for I_{CBO} and h_{FE} degradation ranged from 1 to 20 minutes; recovery has logarithmic time dependence. Typical cycles are shown in Fig. 4 for a transistor which had been pre-irradiated to degrade I_{CBO} from a few nanoamperes to several microamperes.

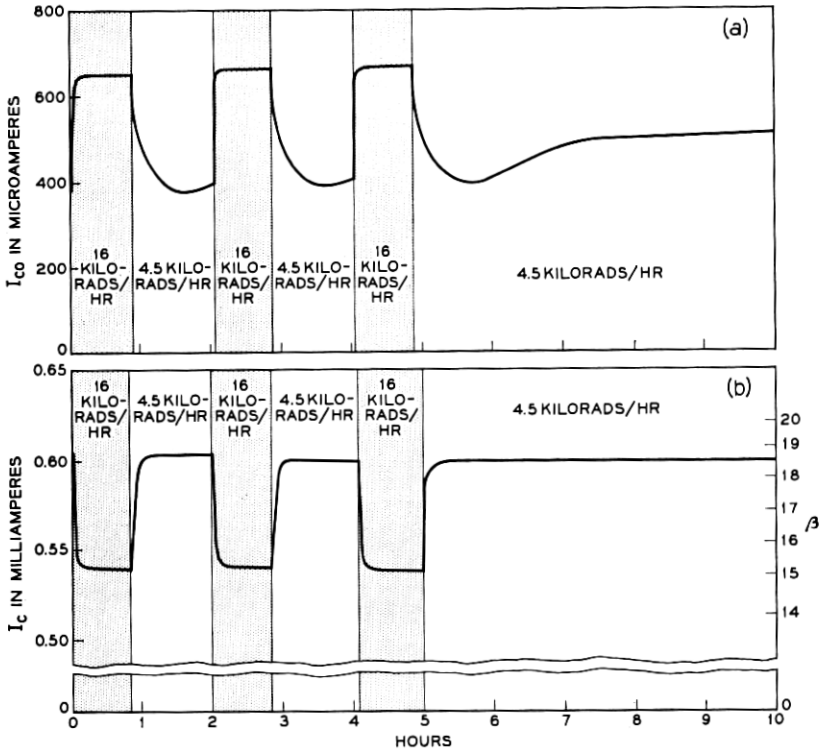
Fig. 5 — Leakage current and gain of a transistor cycled between two high radiation field intensities.

(ii) Short-term reciprocity does not hold; i.e., during cycling tests it was apparent that a given total dose applied at a fast rate caused more degradation than the same dose applied at a slower rate. Note from Fig. 5 that 3.6 hours at 4.5 kilorads per hour induce less effect than 1 hour at 16 kilorads per hour, although the total dose is the same for both cases.

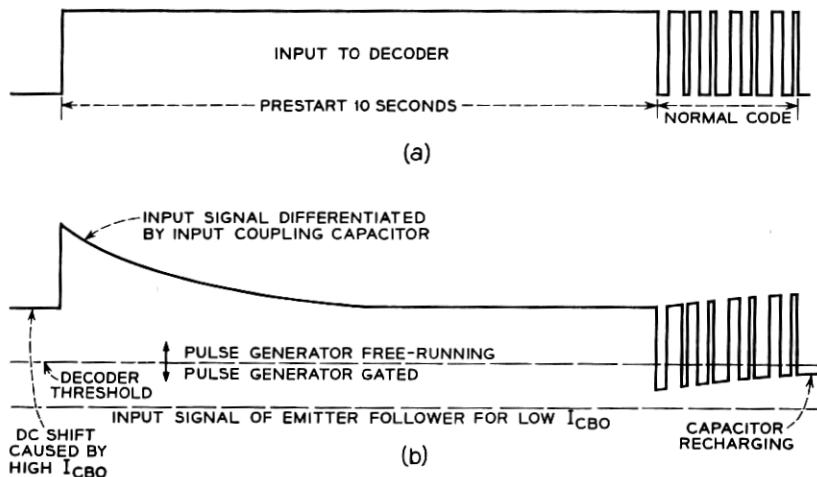
Fig. 7 — Modified command for high I_{CBO} in pulse shaping network first stage.

This circuit is an emitter follower with a high V_{CE} ; high I_{CBO} (>25 microamperes) will force the base voltage of this stage above a threshold level and will consequently cause the pulse generator to free-run. The input of the emitter follower is coupled to the output of the command

receiver through a capacitor. By preceding a normal command signal by a long pulse, as shown in Fig. 7(a), the input capacitor is charged to the full pulse amplitude level. When the pulse is removed, the charged capacitor will serve to pull the base of the emitter follower below the threshold level so that a command may be transmitted during the interval that the capacitor is being discharged by the leakage current (see Fig. 7b).

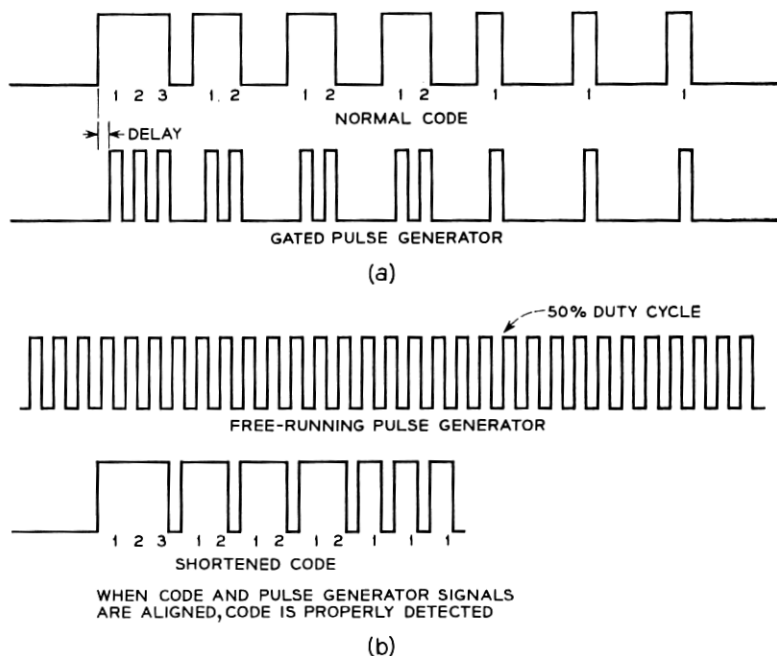
Fig. 8 — Modified command for high I_{CBO} in pulse shaping network second stage.

If the leakage current of this stage is above 150 microamperes, the pulse generator will free-run. Leakage currents in excess of 300 microamperes will cause the digit gates to be held off; consequently, the modified command signal described here will be effective only for a leakage current below 300 microamperes. Normally, the pulse generator, a gated astable circuit, is allowed to free-run only when an input pulse is present, as shown in Fig. 8(a). The modified command consists of a near-standard command set up on a shorter time interval basis, so that the input pulses are occasionally "in phase" with the free-running astable circuit, as shown in Fig. 8(b). With the shortened code it is possible to cause spurious decoder response when proper phasing does not exist. Errors can be avoided if the command pulse sequence is very carefully established.

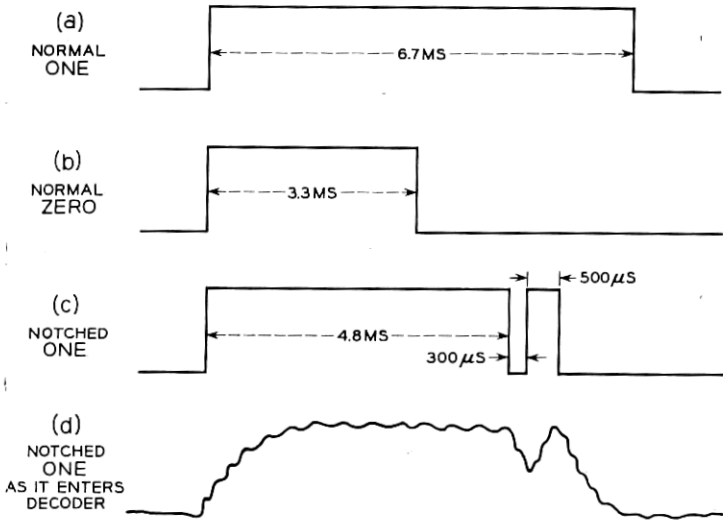
Fig. 9 — Modified "one" to circumvent failed zero digit gate.

The failure was traced to low h_{FE} in the "zero" digit gate transistor, which, because of its load configuration, had a turn-on time which was too slow to advance the digit counter.¹ Measurements on the device confirmed the diagnosis.

If the gain of the zero digit gate transistor becomes sufficiently low in value, that stage will not be capable of driving the digit counter. As one sees from Fig. 6, the zero digit gate drives the digit counter and the timer; the one digit gate drives the digit counter, and, after a small amount of delay, drives the store. The scheme for circumventing the failed zero digit gate is to send in place of a "zero" a modified "one" code in such a way that the one digit gate is turned on and almost immediately turned off again. By use of the notched and shortened pulse in Fig. 9(c), it is possible to advance the digit counter but not to build up sufficient voltage to set a "one" into the store. Thus this notched "one" causes the same response in the digit counter and store as a "zero." Unfortunately, the notched "one" does not fully enable the timer circuit, and it is difficult to handle codes containing three sequential "zeros," unless these "zeros" are at the end of the code.*
