## Transmission Cathodoluminescence

By A. K. CHIN, H. TEMKIN, and S. MAHAJAN

*The application of transmission cathodoluminescence (TCL) in evaluating the quality of luminescing materials is reviewed. This scanning electron microscope technique is particularly useful in imaging localized nonuniformities, such as dislocations and inclusions, in semiconductors. Understanding and analyzing such material defects are of practical importance since they greatly affect device performance and lifetime. After a detailed description of TCL, the advantages of this technique in comparison to defect etching, cathodoluminescence imaging, and electron beam-induced current (EBIC) is presented. Since TCL is simple to perform, this technique can be used to evaluate and monitor material growth and device processing procedures. Although TCL may be applied to any luminescing material, this paper demonstrates its usefulness for the GaAs/GaAlAs and InP/InGaAsP materials systems which provide most sources and detectors for optical communication.*

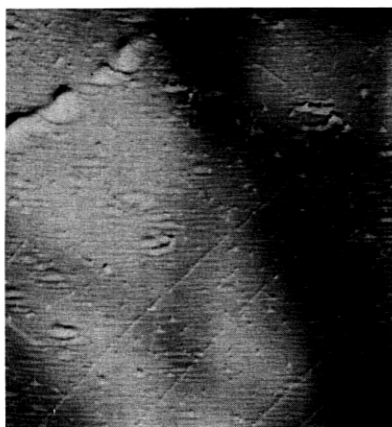
Fig. 17—(a) Secondary electron image of a DH InP/InGaAsP wafer. Growth lamellae, hillocks, and surface scratches are observed. (b) Cathodoluminescence image of the region shown in (a). The dark areas are surface defects. (c) Transmission cathodoluminescence image of the region shown in (a). The vertical and diagonal lines not seen in the CL image are misfit dislocations.

with  $\Delta a/a = 0.12$  percent. The active layer is  $\sim 0.5 \mu\text{m}$  thick and may be used for either LEDs or lasers. In Fig. 17a, the SE image of the top epitaxial layer shows growth lamellae, hillocks, and surface scratches. The epilayers were grown on a  $\{111\}$  oriented substrate. Most of the

features of Fig. 17a are reproduced in Fig. 17b which shows a CL picture of the same region. The CL image was taken with an S1 photomultiplier which has a spectral response similar to that of an Si photodiode. Dark nonluminescing regions are clearly visible. Finally, in Fig. 17c, we show the TCL picture obtained with an Si detector. Additional features not observed in either SE or CL modes of the SEM are the large number of sharp diagonal and vertical dark lines which form an angle of  $\sim 60^\circ$  between them. These lines are not within the electron beam range on the surface since they do not appear in the CL image. It is suggested that they are misfit dislocation at the InP buffer layer-InGaAsP active layer interface. Similar TCL imaging of lattice mismatched epilayers grown on {100} oriented substrates reveals two sets of orthogonal dark lines, providing additional support for this interpretation. Additionally, X-ray topographs of lattice mismatched {111} oriented wafers show images of misfit dislocations similar to those shown in Fig. 17c.<sup>40,59</sup>
