## Soil Burial Tests:

# Effect of Soil Burial Exposure on the Properties of Rubber, Crosslinked Polyethylene, and Vulcanized Wire Coatings

By G. H. BEBBINGTON

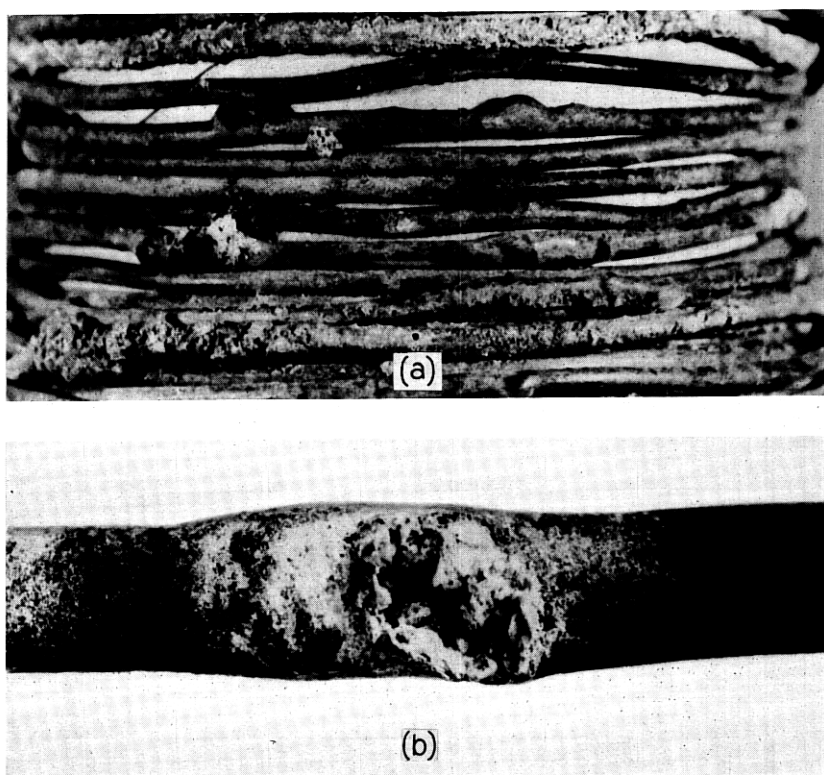
Fig. 1—(a) Blisters and surface deposits on a spool of SBR insulated wire #302A-1 after one year burial at Bainbridge. (b) Enlargement of a burst blister on this specimen.

Figure 1a shows a reeled length of the blistered SBR insulated wire #302A-1 and Fig. 1b is an enlargement of one of these blisters. This type of blister was common also on the A-1 samples (under potential) #303, 304, 308, and 310.<sup>5</sup> The copper-steel conductors under the rubber insulation of some of these were found to contain pits due to corrosion in their copper coatings. But not all blistered specimens had corrosion pits, nor did all pitted specimens have blistered insulations. Pronounced

pitting was found on the #305A-1 and #307A-1 samples and on the A-11 samples (without potential) #301, 304, 308, and 309. In general, the specimens under potential showed more degradation than those without potential and the degree of corrosion seemingly had little correlation with most of the rubber compounds tested.

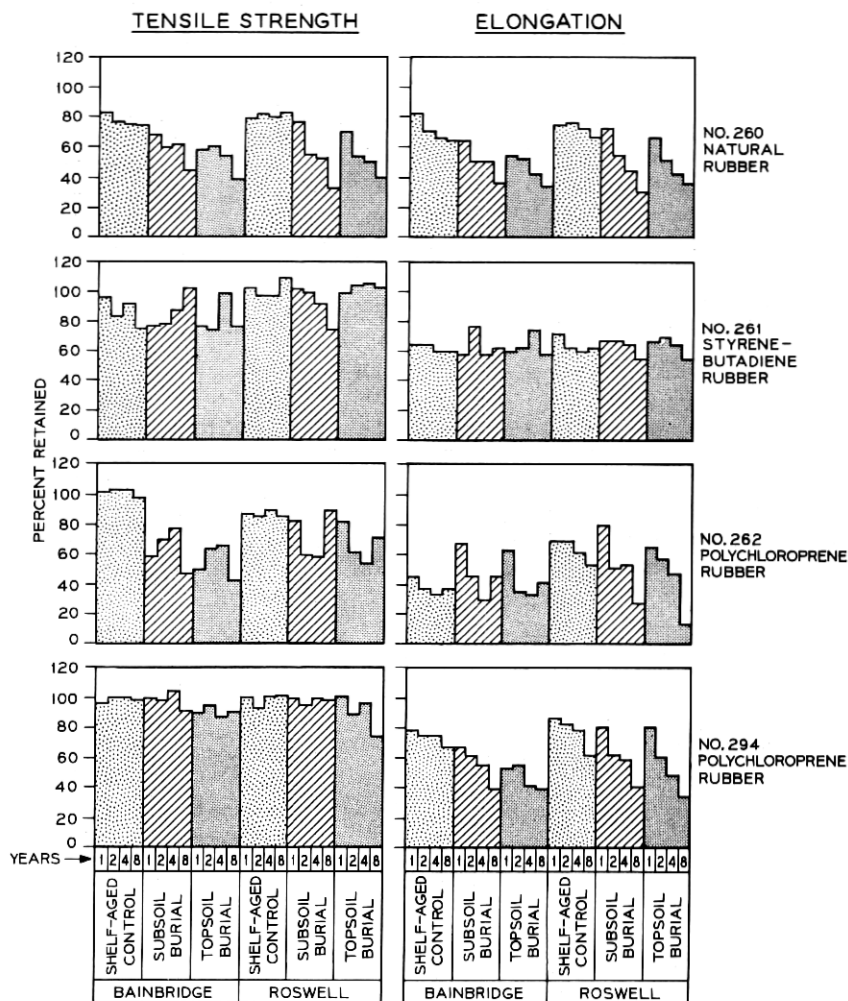
Fig. 4—Buried molding compounds (#260–262, 294)—percentage of retained tensile strength and elongation versus time of soil burial.

The initial clay-loaded black polychloroprene #262 failed badly (50 percent loss in tensile strength) in less than one year due to water absorption. A second CR composition (#294) designed for soil burial with an easy processing channel (EPC) black loading and no clay showed greater resistance to deterioration. It retained its physical properties but during eight years of exposure it sustained much insect damage, particularly in New Mexico.

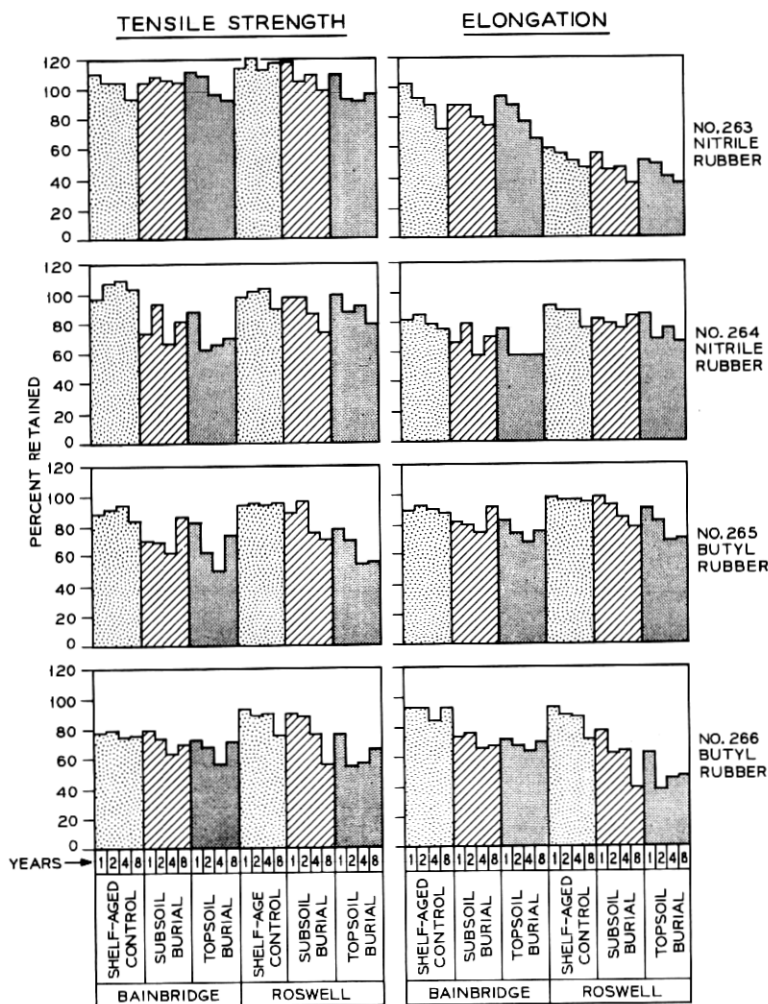
Fig. 5—Buried molding compounds (#263-266)—percentage of retained tensile strength and elongation versus time of soil burial.

The compound showing the best performance in the first series of vulcanizates was #263—the high nitrile NBR with an EPC carbon black filler. Although there was some loss in elongation in New Mexico, the specimens were still in excellent condition when removed from both exposure sites after an eight-year burial. A loss in elongation was also found in the shelf-aged specimens so this did not probably result from the soil burial.

On the other hand, the nonblooming, heat resistant nitrile #264 lost about 20 to 25 percent of its original tensile strength while the elongation of the control remained fairly constant. It also had little insect damage.

The IIR formulations #265 and 266 were designed for use as hydrophone diaphragms and involve different curing systems. The sulfur cure in #265 was found to corrode any contacting metal parts so a quinoid cure was provided in #266. Both butyls retained their physical properties fairly well (see Figure 5), but suffered considerable insect damage, particularly in New Mexico. Thus the test values vary greatly.

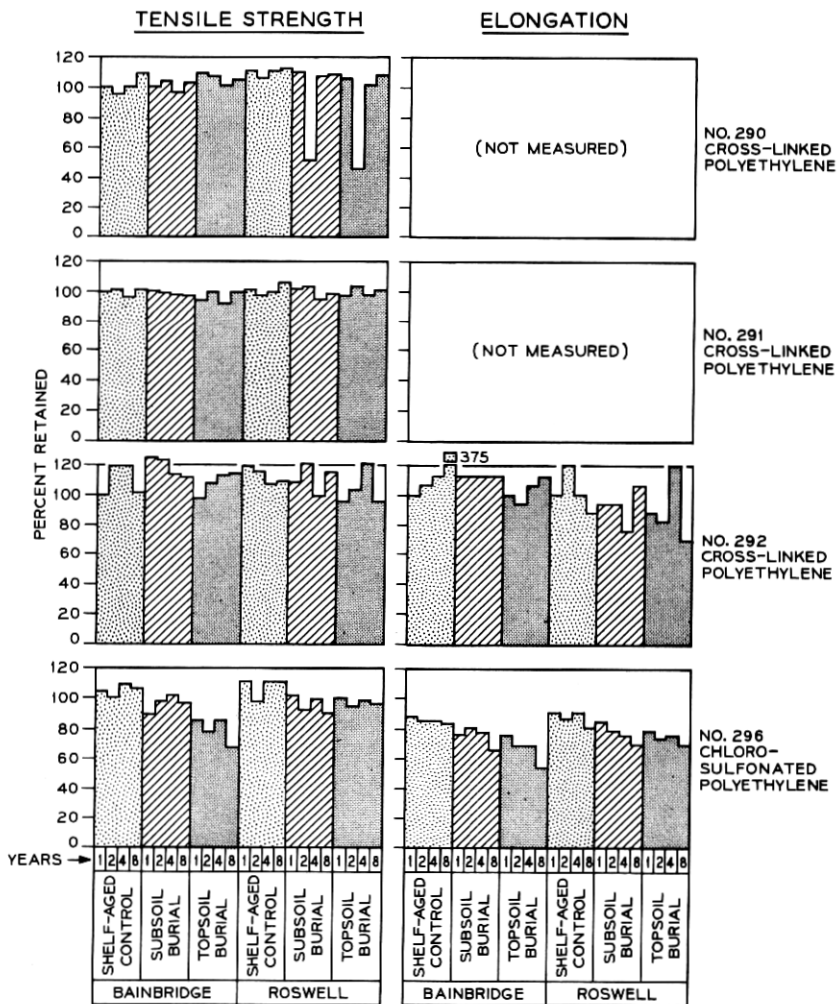
Fig. 6—Buried molding compounds (#290–292, 296)—percentage of retained tensile strength and elongation versus time of soil burial.

ically crosslinked polyethylene molded samples #290–292 appear to be unaffected by soil exposure and are being continued in the burial program.

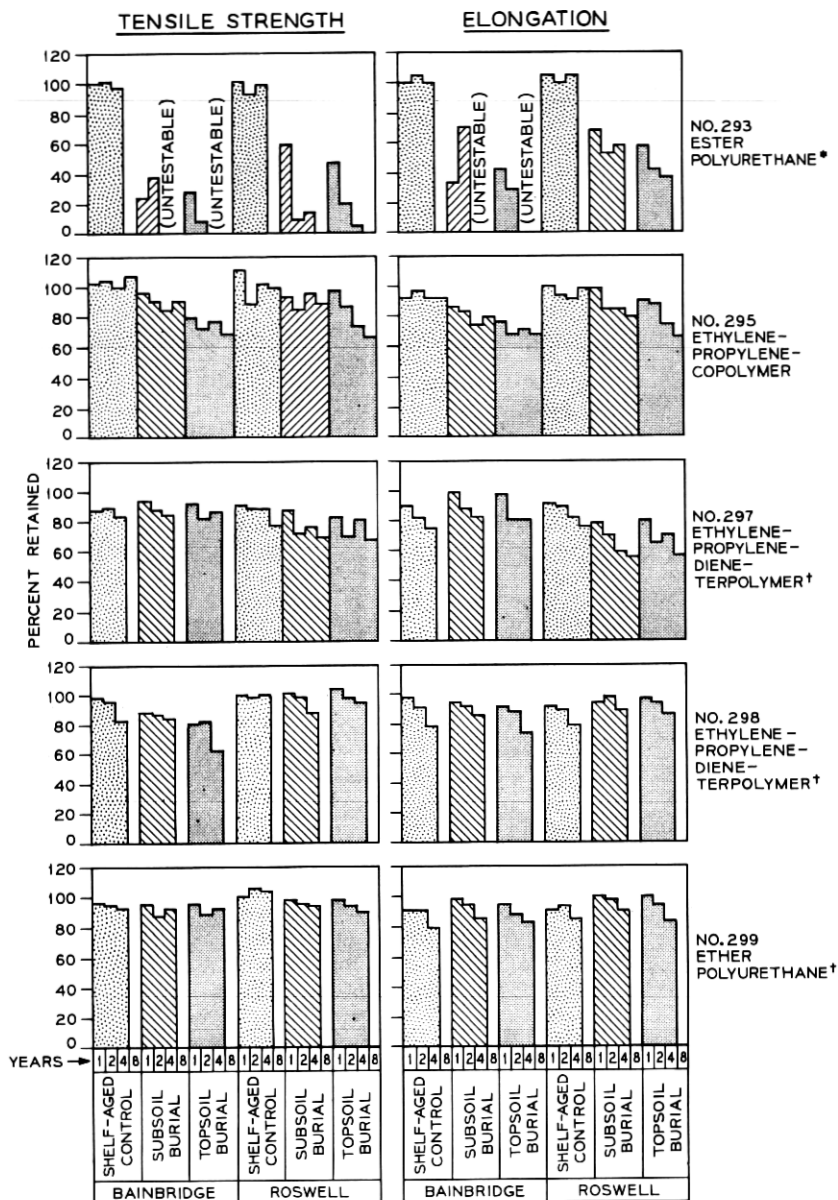
\*-AFTER 4 YEARS ALL OF THE BURIED SPECIMENS COULD NOT BE TESTED

†-EIGHT YEAR DATA NOT YET AVAILABLE

Fig. 7—Buried molding compounds (#293, 295, 297-299)—percentage of retained tensile strength and elongation versus time of soil burial.

This burial program has clearly demonstrated that the polyester urethane vulcanizate (#293) was biologically susceptible and subject to hydrolysis. This was evident after only one year of burial, for the #293

specimens already had deep cracks. Degradation was so severe that specimens could not be retrieved and tested after six years of exposure. In contrast, the polyether urethane compound (#299) was virtually unaffected by soil burial.

The last three compounds in this program—two EPDMs with and without clay, #297, 298, and the sulfur-cured polyether urethane #299 represent four-year exposure data. Some losses in physical properties are indicated, particularly in elongation for #297 and #298. The #299 polyurethane also shows a very slight loss, as did the shelf-aged controls. None of the three suffered any insect damage.

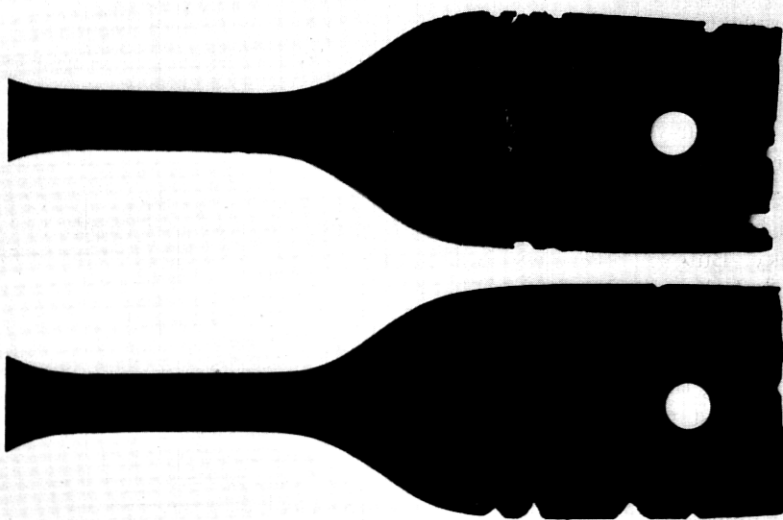
Fig. 9—Insect damaged specimens of butyl molding compounds #265 and #266 after four years burial at Roswell.

It was unfortunate that precut dumbbells were used for testing the soil burial properties of the molding compounds because insects or rodents chewed the edges of the dumbbells. Some of these damaged specimens are shown in Figs. 8 and 9. It is now obvious that complete molded sheets should have been buried so that test specimens could have been cut from undamaged areas.

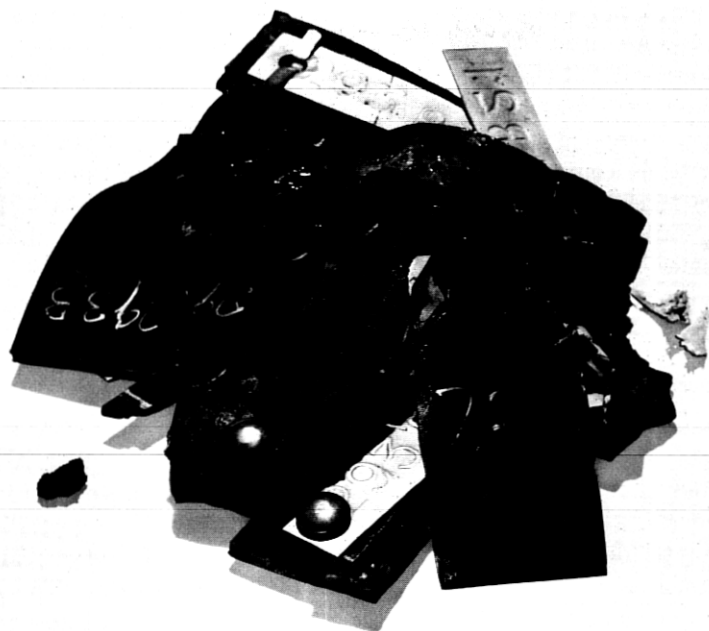
Fig. 10—A mixed pile of tested specimens of #293 polyester urethane from four years shelf-aging and four years burial at Roswell which have been in storage together for five years. Generally, the buried specimens were brittle and the shelf-aged were tacky, but where they have been in contact with each other, the shelf-aged controls were found to have liquified.

Figure 10 displays one more phenomenon involving the ester polyurethane sample that has occurred in the exposure test. The remains

of the four-year shelf-aged control specimens and those that were retrieved after four years burial at Roswell were stored together after they had been tested. When examined after five years of storage, the burial specimens were found to be brittle and the controls to be tacky. But wherever they had been in contact with each other, the controls had liquified as is illustrated by the shiny wet areas in the photograph. In this same period of time, the remaining untested control specimens in this experiment are also getting moist and approaching this liquid state without contact with any other specimens.

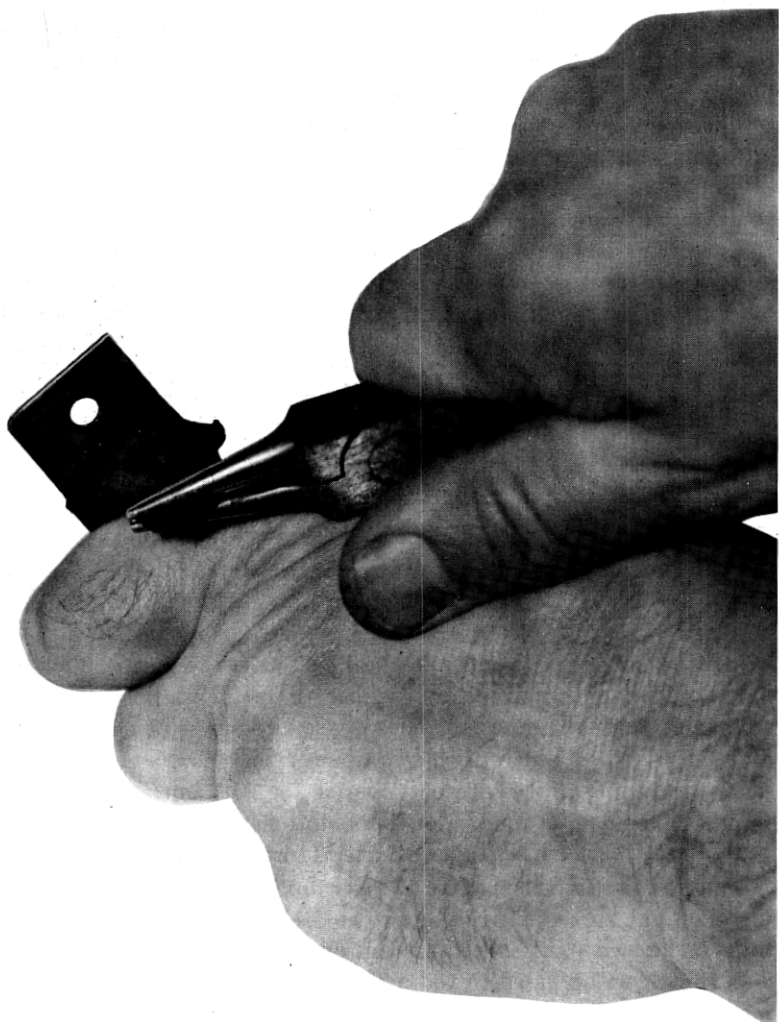
Fig. 11—Hand-peel test used to determine the strength of rubber-to-metal bond. Specimen is #275-SBR compound M-206 bonded to stainless steel with the Chemlok 201 plus Chemlok 220 system—after retrieval from Bainbridge.

Figure 11 illustrates the comparative pull test used in this program. If the bond is weak, an adhesion failure occurs and no rubber is left on the metal. If the rubber is weak, a cohesion failure occurs and it tears leaving a major portion of the rubber adhering to the metal. Strong bonds and strong rubbers are very difficult to pull apart.

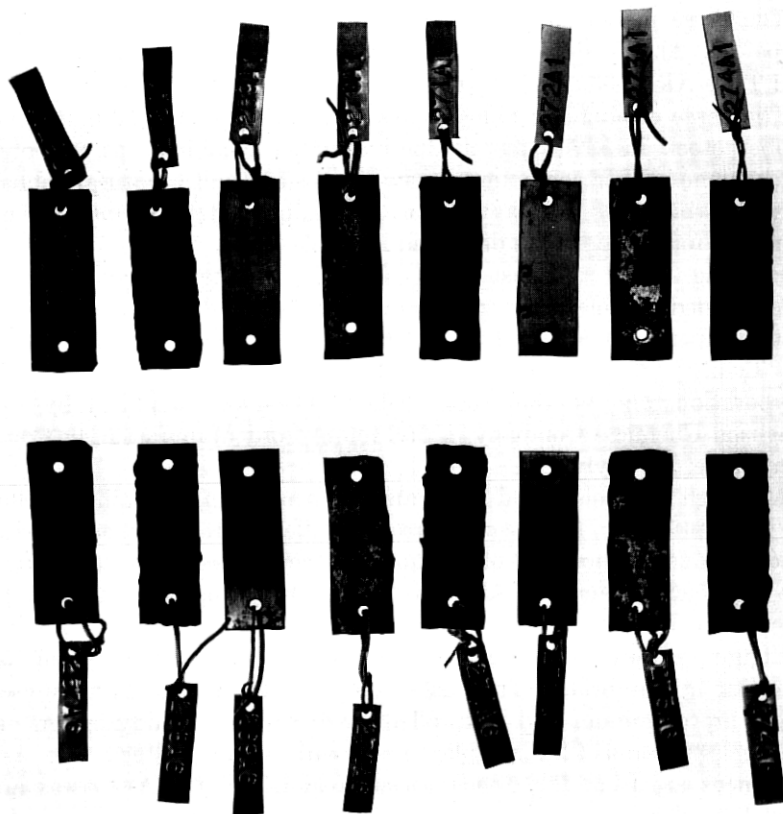
Fig. 12—Rubber-to-metal bonded laminate specimens after one year burial at Bainbridge. The A-1 specimens were buried in the topsoil, and the A-6 specimens were in the subsoil. Samples #269 and #272 are bonds to stainless steel while the corroded remainder are either cold-rolled steel or aluminum.

Figure 12 shows a number of specimens retrieved after burial for one year in Bainbridge. The visibly corroded specimens in the photograph are aluminum and cold-rolled steel, while the shiny specimens are the #269 and #272 samples made with stainless steel. The A-1 specimens are from the 6-inch topsoil region and the A-6 items are from the subsoil.

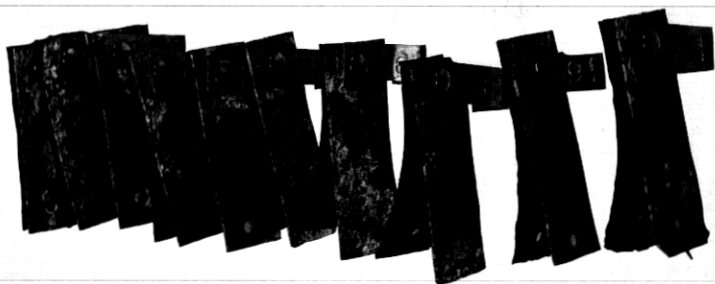
Fig. 13—Specimens of the five rubber-to-aluminum bonded combinations retrieved from two depths after four years soil burial exposure at Roswell. All bonds have failed due to severe corrosion.

The very severe corrosion of the untreated aluminum which occurred in the soil has destroyed the bonds of all five of the aluminum burial laminates shown in Fig. 13. In the polychloroprene aluminum specimens #279 (Fig. 14) the corrosion seems heavier at the rubber-metal interface than on the outside, indicating possible corrosion due to differential aeration and accelerated by chloride contaminants.<sup>8</sup>

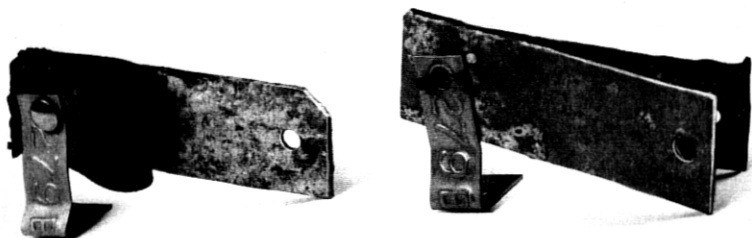
Fig. 14—Heavier corrosion at the interface of the polychloroprene-to-aluminum bond than on the exposed side of the metal strip.
