The Command System Malfunction of the *Telstar* Satellite

By J. S. MAYO, H. MANN, F. J. WITT, D. S. PECK,
H. K. GUMMEL and W. L. BROWN

Loss of the command function of the Telstar satellite first occurred on November 24, 1962. There had been earlier indications of degraded performance. Facts are presented which led to the conclusion that the malfunction of the command system was due to surface damage to certain transistors in the redundant command decoders by the enhanced radiation in the inner Van Allen belt.

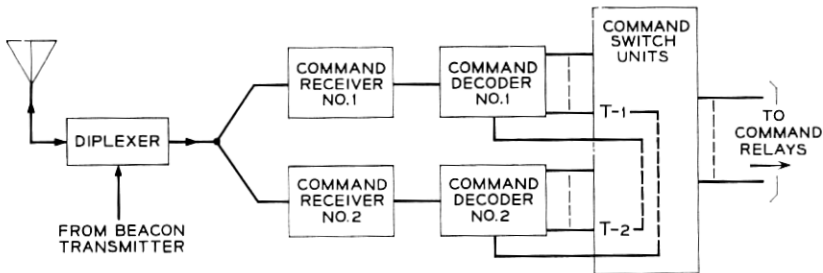
There are two virtually identical command decoders in the command system. Each is driven by one of the two command receivers and each drives a command switch unit, as shown in Fig. 1. Each command relay is normally driven by both command switch units in parallel; the design is such that a pulse from either or both command switch units is sufficient to operate a relay. Thus, redundancy exists between the input to the command receivers and the output of the command switch units.

Fig. 1 — Block diagram of command system.

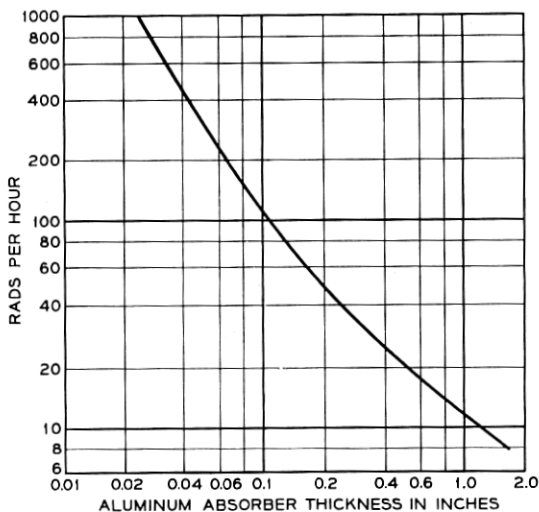
The estimated upper limit of the radiation dose contributed by energetic protons in the region of highest intensity is illustrated in Fig. 2 as a function of aluminum absorber thickness. The radiation dose rate is shown under the assumption of uniform shielding and exposure to a uniform omnidirectional proton flux. For the decoders which are very close to the surface of the electronics canister, the minimum shield thickness is only about 0.1 inch of aluminum, but the solid angle for acceptance of particles through this thickness is between $\frac{1}{4}$ and $\frac{1}{2}$ of the total 4π solid angle. The curve applied to this case gives an orbital average of between 5 and 10 rads per hour. The proton exposure of the satellite has been quite close to the pre-flight estimate.

Fig. 2— The radiation due to high-energy protons in the peak of the inner Van Allen belt.

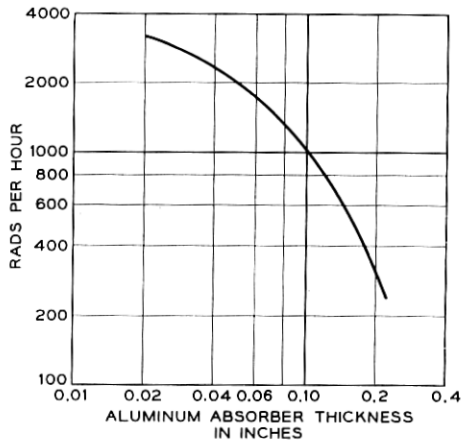
The omnidirectional electron flux averaged over the first four months of the Telstar satellite's orbit is about 10^8 electrons/cm² sec. The radiation dose rate for electrons with this flux and the above spectrum is shown as a function of shield thickness in Fig. 3. The curve represents the radiation in the Telstar canister for shielding thicknesses small compared to that in the middle of the canister.* For transistors in the

Fig. 3 — The average radiation due to high-energy electrons in the Telstar orbit.

decoder the dose rate due to electrons is approximately 10^3 rads/hour. The estimated dose rate due to protons is only 5 to 10 rads/hour. Hence the components in the Telstar command decoder have been exposed to approximately 100 times the anticipated radiation intensity, and the major contribution is not from protons but from high-energy electrons. It is believed that the peak radiation intensity could be as high as 10^4 rads/hour. The bremsstrahlung is insignificant in comparison with the direct electron effects.

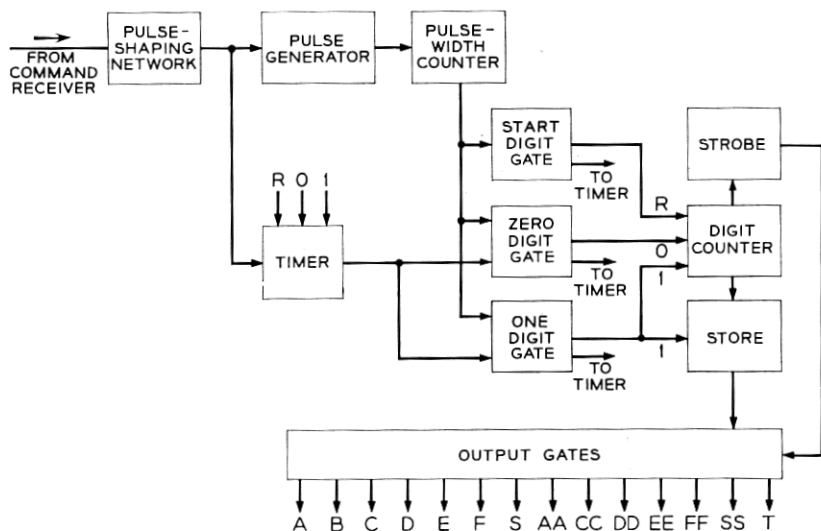
The five most vulnerable transistor stages, selected in the manner described in Section 5.1.4, require the use of different modified command signal structures to accomplish proper decoding in failed units. The relative location of each of these stages can be determined from the block diagram of the command decoder shown in Fig. 6. A detailed description of the operation of the decoder circuit is given in Ref. 1.

Fig. 6 — Command decoder block diagram.

If the gain of the zero digit gate transistor becomes sufficiently low in value, that stage will not be capable of driving the digit counter. As one sees from Fig. 6, the zero digit gate drives the digit counter and the timer; the one digit gate drives the digit counter, and, after a small amount of delay, drives the store. The scheme for circumventing the failed zero digit gate is to send in place of a "zero" a modified "one" code in such a way that the one digit gate is turned on and almost immediately turned off again. By use of the notched and shortened pulse in Fig. 9(c), it is possible to advance the digit counter but not to build up sufficient voltage to set a "one" into the store. Thus this notched "one" causes the same response in the digit counter and store as a "zero." Unfortunately, the notched "one" does not fully enable the timer circuit, and it is difficult to handle codes containing three sequential "zeros," unless these "zeros" are at the end of the code.*
