The Design and Construction of the Electronics Package

By R. H. SHENNUM and E. J. REID

The electronics system of the Telstar satellite is described from the point of view of philosophy of design and construction rather than that of circuit details. The reliability is emphasized, and steps taken to preserve the inherent reliability of the components are discussed. The physical construction of modules, subsystems, and finally the entire system is described, including the foam encapsulation and the eventual hermetic sealing of the canister.

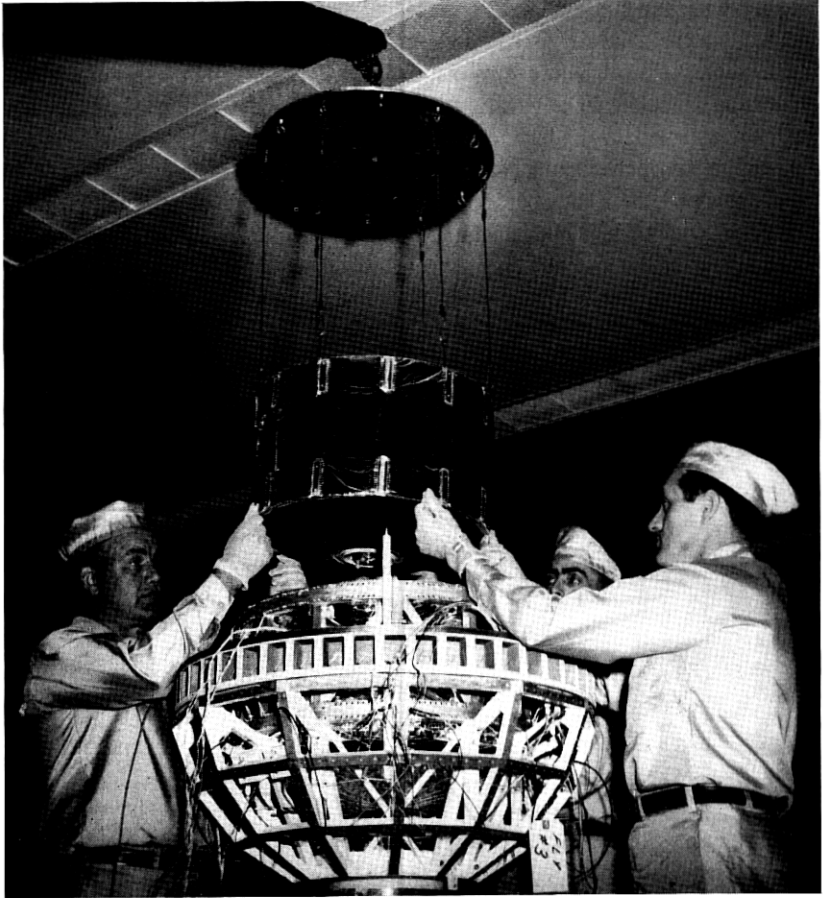
Fig. 9 shows the completed canister with the domes welded in place. Before it is installed in the frame, the hermetically sealed canister is

Fig. 9 — Mounting of electronics canister into the frame.

Fig. 9 also illustrates the working conditions which were enforced during the entire construction process. The construction area was air-conditioned; air-conditioning provided triple filtering to remove foreign particles, a 75°F* temperature, and a 35 per cent † relative humidity. In addition to the special mechanical and electrostatic air filtering, stringent controls were imposed to minimize the introduction of contaminants. These included:
